BUILDING ANALYSIS REPORT

Client: *John Doe*

Property Location: *Address*
Washington, DC 20020

Date of Inspection: *7/2/2017*

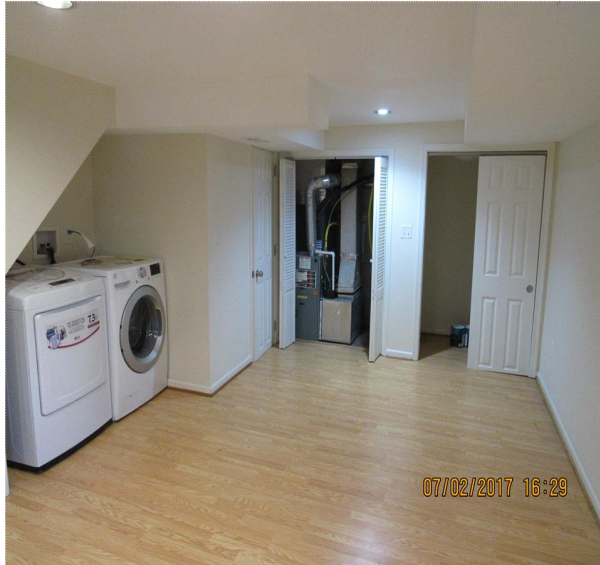
IMG_6413.JPG

Remarks	<i>Areas of the laminated wood floor are soft and unlevel. Only 60% of the floor to ceiling height is 6ft - 10inches. the other floor to ceiling height is only 6ft due to air ducts.</i>

View of the basement. Notice the floor to ceiling height at the air ducts and the floor. It is only 6 feet. Notice the floor to ceiling btw the duct. It is 6 ft - 10 inches. Ducts cover

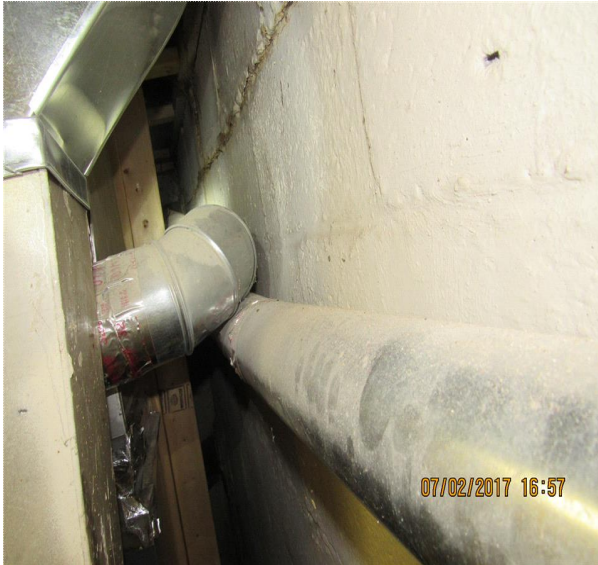
IMG_6428.JPG

The foreground shows the exhaust connector to the water heater. It spans under the exhaust for the gas furnace. The should not touch. The furnace exhaust should connect to the

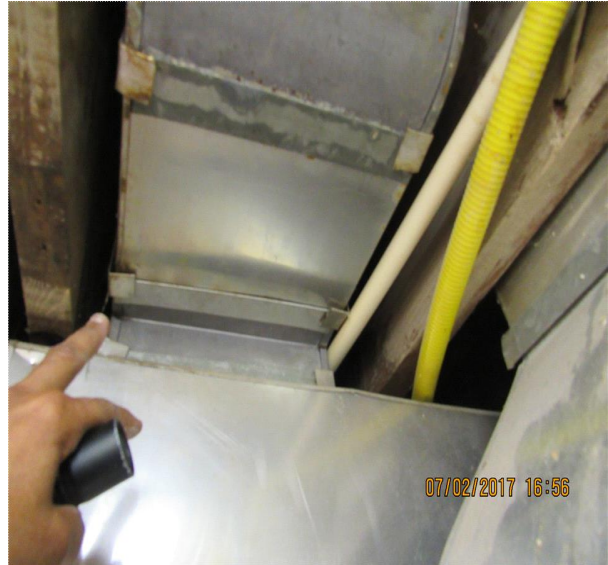
IMG_6424.JPG

Poor seals for the air duct. Some joints are not sealed.

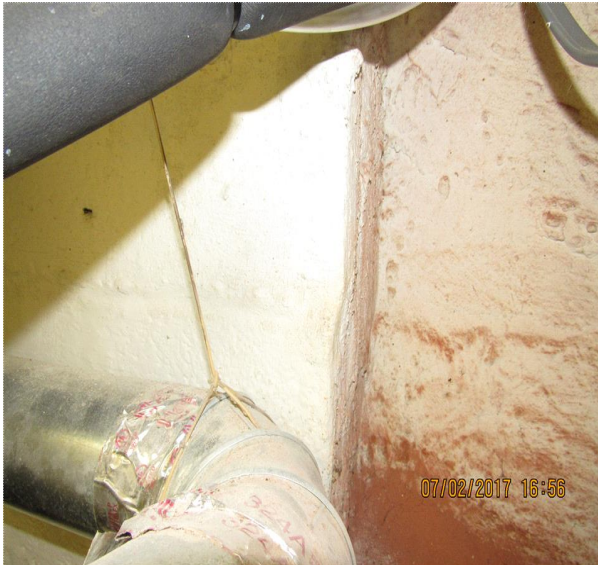
IMG_6426.JPG

Showing string is used for supporting the water heater exhaust duct.

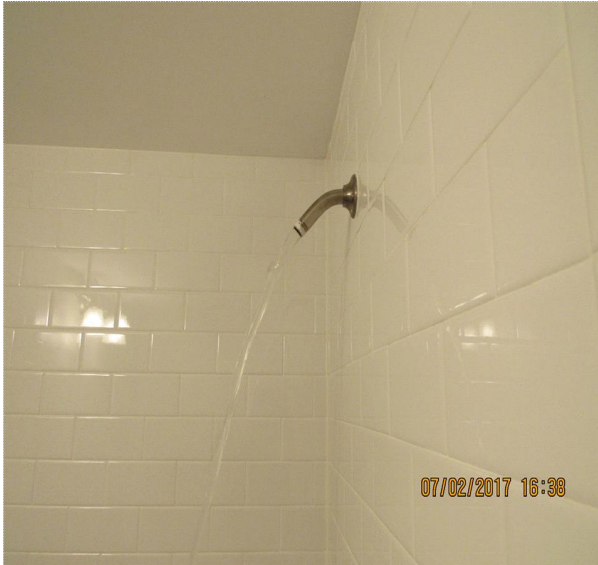
Remarks:	No shower head for the shower 2nd floor bath. Poor performance of shower in basement.

IMG_6420.JPG
Missing shower head.

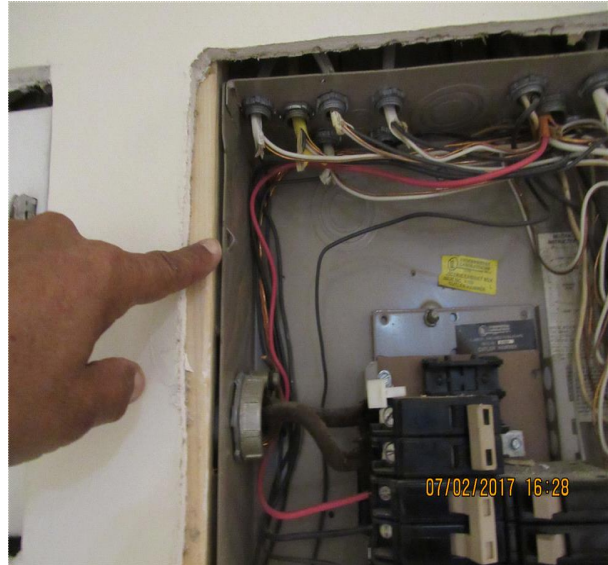
IMG_6412.JPG
Showing slot for a screw to attach the dead front cover. The dead front does not have holes to correspond with the 2 top slots.

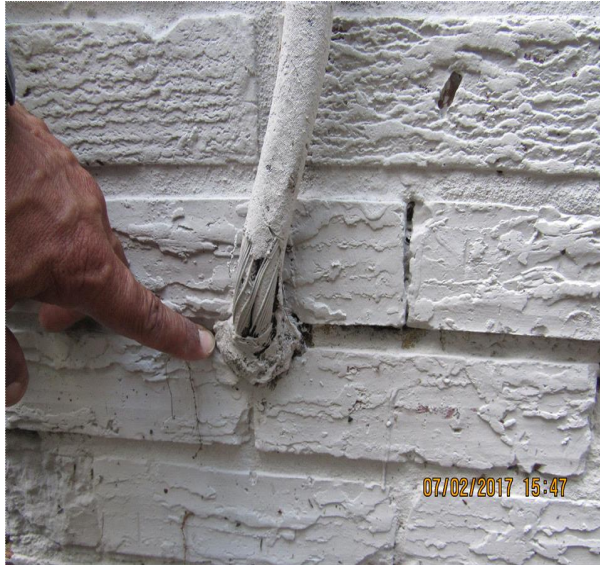
IMG_6378.JPG

Showing severe deterioration of the main electric service cable and poor seal at the wall penetration.

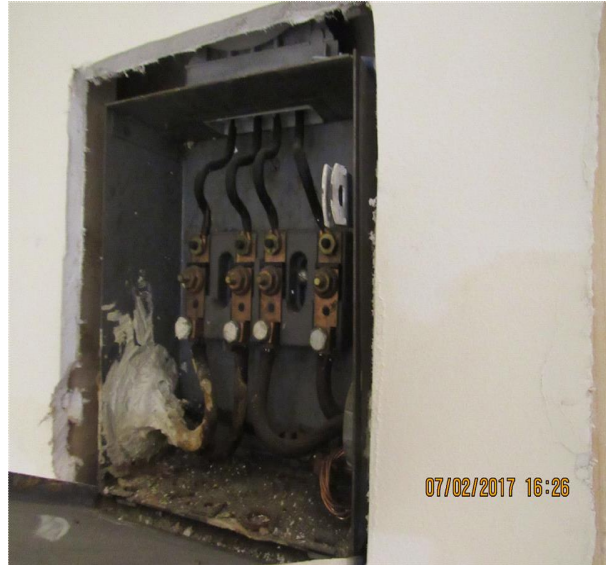
IMG_6410.JPG

Showing the electric service connections from the meter. Recom'd a licensed electrician to evaluate this setup.

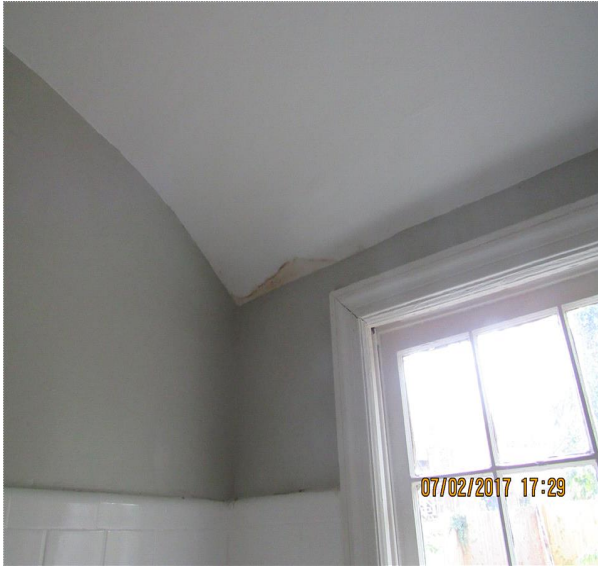
IMG_6438.JPG

Showing a water stain at the ceiling to the 2nd floor bathroom. Suspect water spilling over the gutter that is full of debris,

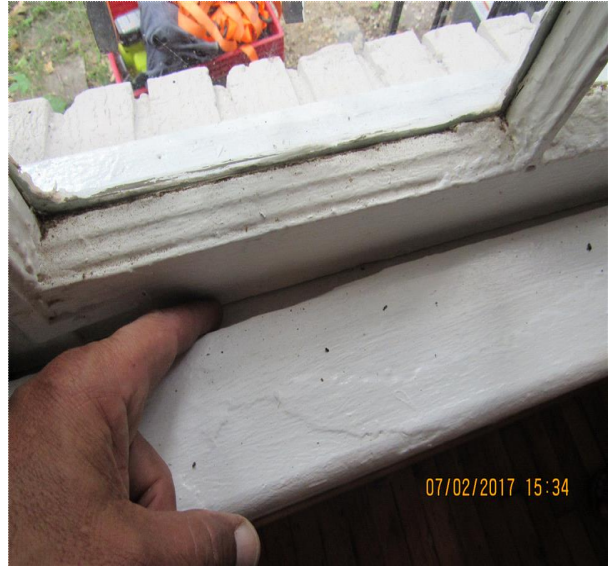
IMG_6374.JPG

Showing damage of one of the windows where the sill has been chipped away. Water

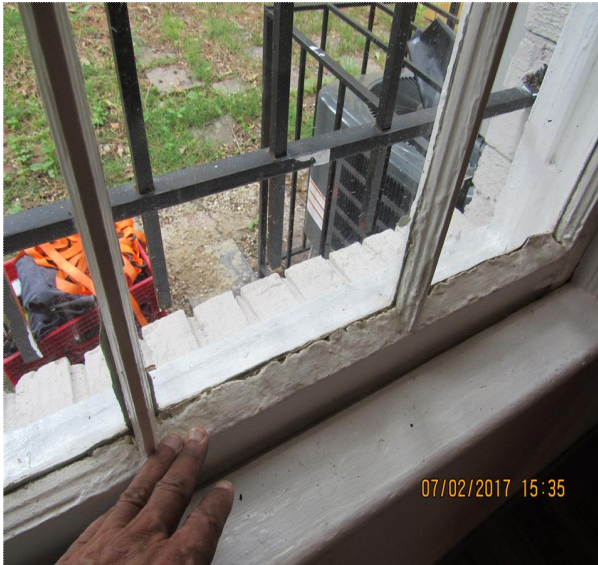
IMG_6375.JPG

Showing poor repair of the single glazed window. Notice there are no screens or storm windows.

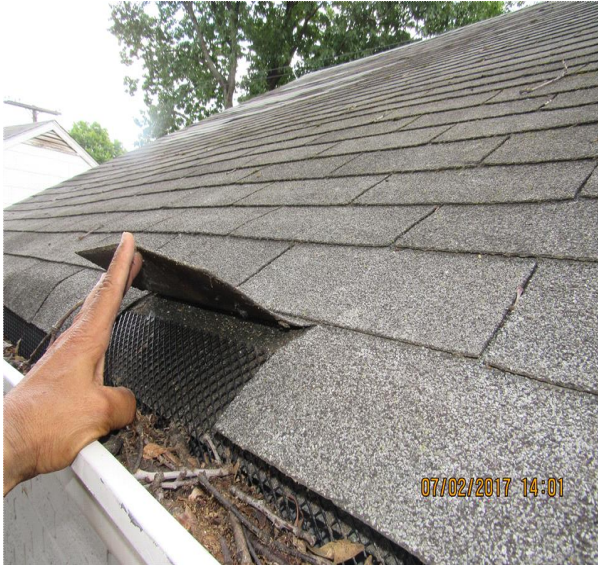
IMG_6338.JPG

Showing the condition of the gutter and the poor performance of the gutter guard.

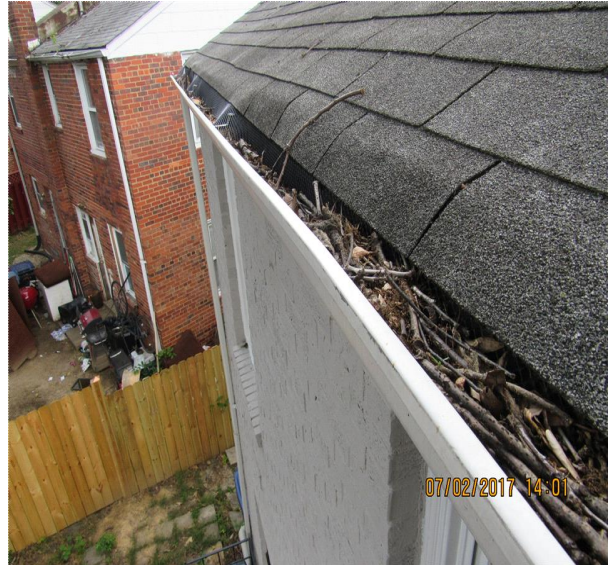
IMG_6339.JPG

Gutters are full of debris. Water may be spilling over the back side of the gutter and finding its way to the 2nd floor bathroom ceiling.

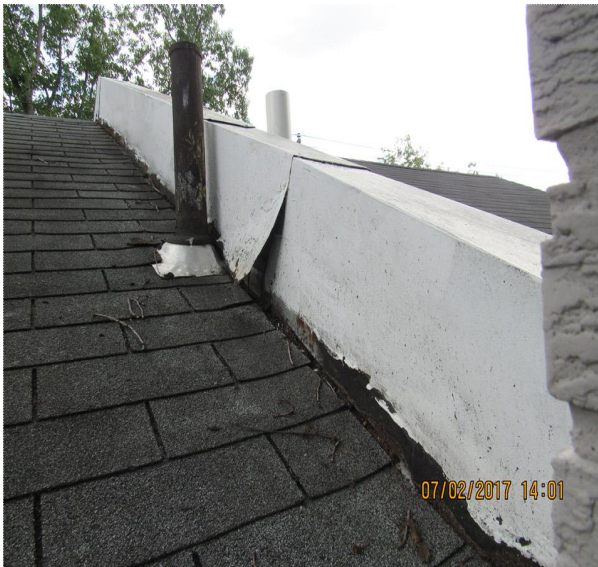
IMG_6341.JPG

Damaged flashing along the party wall.

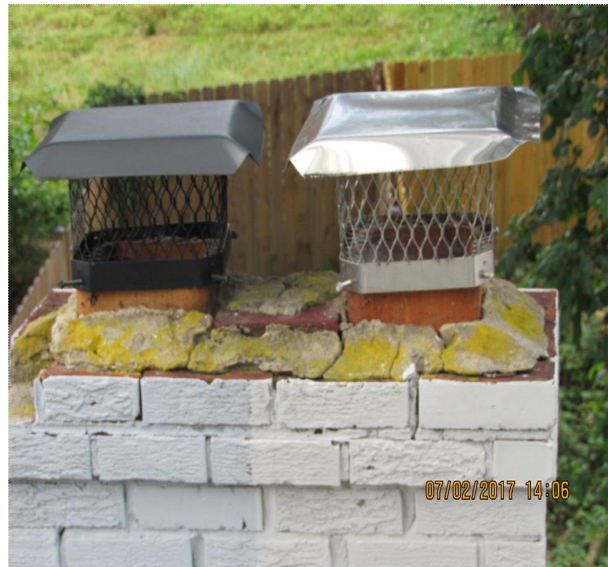
IMG_6356.JPG

Showing the eroding condition of the chimney cap that should be providing a seal around the taracota flue. This should be completely restored.

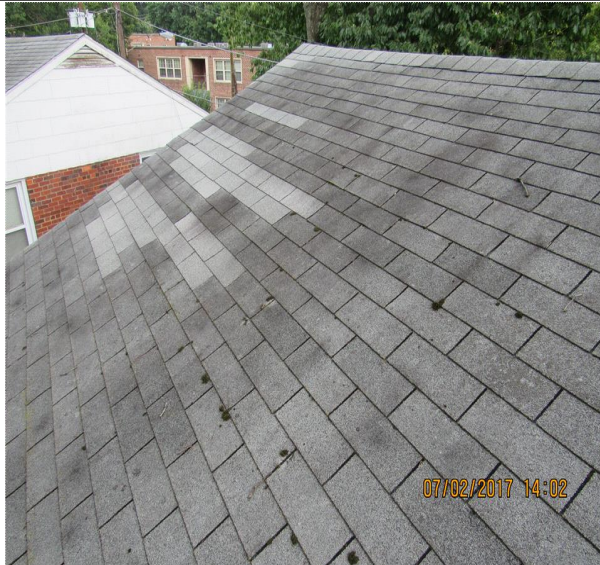
IMG_6342.JPG

The spots on the roof is moss and/or vegetation grow. Notice there has been repairs to the roof.

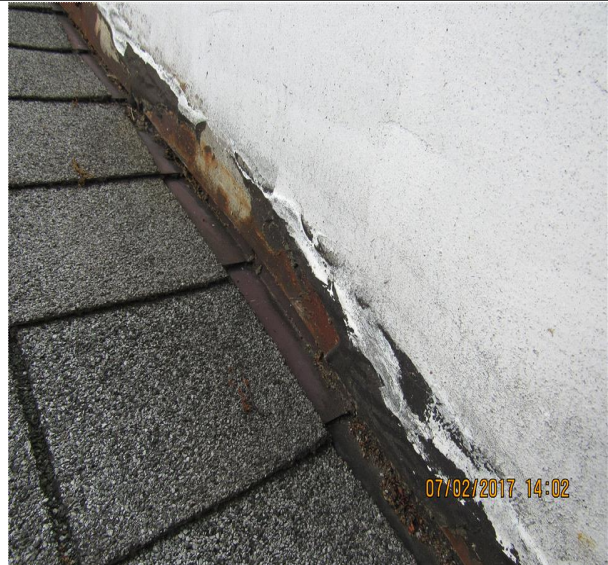
IMG_6343.JPG

Showing the poor flashing at the party wall.

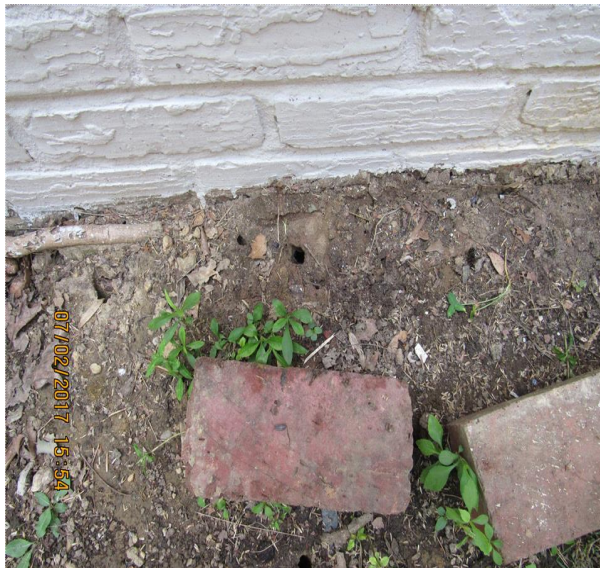
IMG_6387.JPG

Showing holes in the ground that may belong to threatening insects,

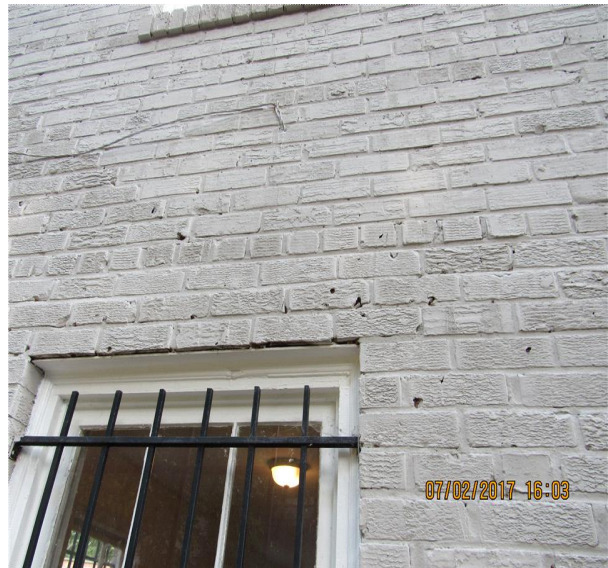
IMG_6395.JPG

Showing a multitude of holes in the exterior masonry that should be cease
